TECHNICAL ASSISTANCE TEAM FOR EMERGENCY RESPONSE REMOVAL AND PREVENTION
EPA CONTRACT 68-01-7367

MEMORANDUM

SUBJECT: Montreal Court Drum Site
Tucker, Dekalb County, Georgia
TDD #04-9004-40-3216
40A-3266
TAT #04-F-04036

DATE: 13 June 1990

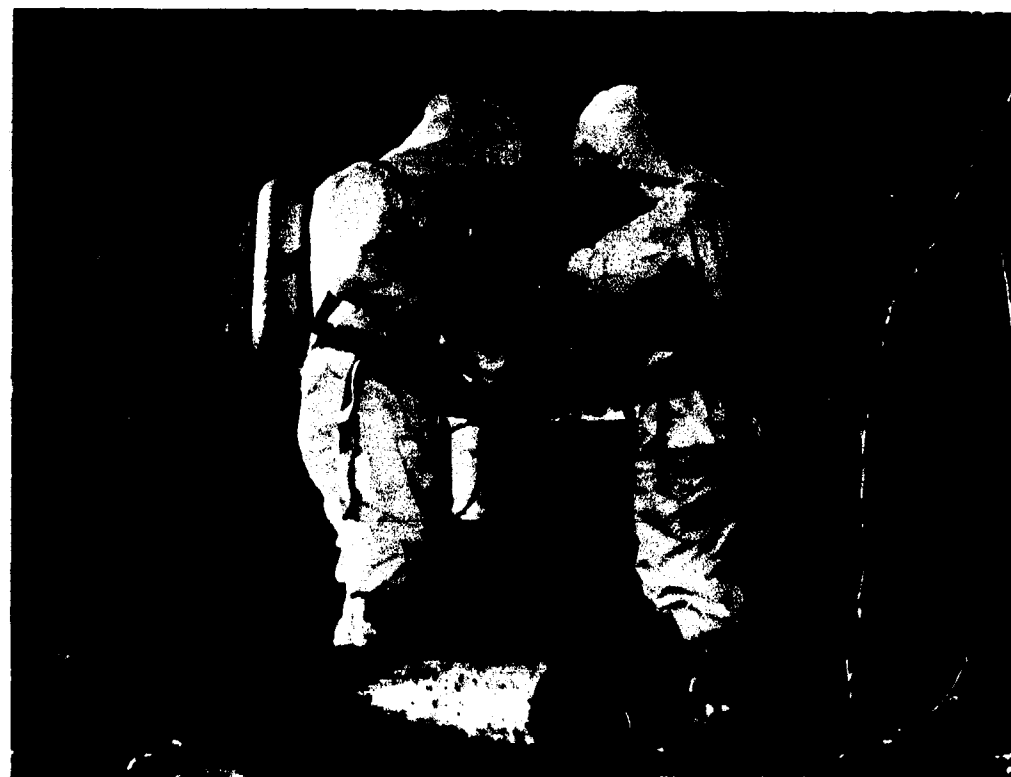
PHOTO #4
OFFICIAL PHOTOGRAPH
ENVIRONMENTAL PROTECTION AGENCY

Subject: TAT sampling drum while
 monitoring for organic vapors.

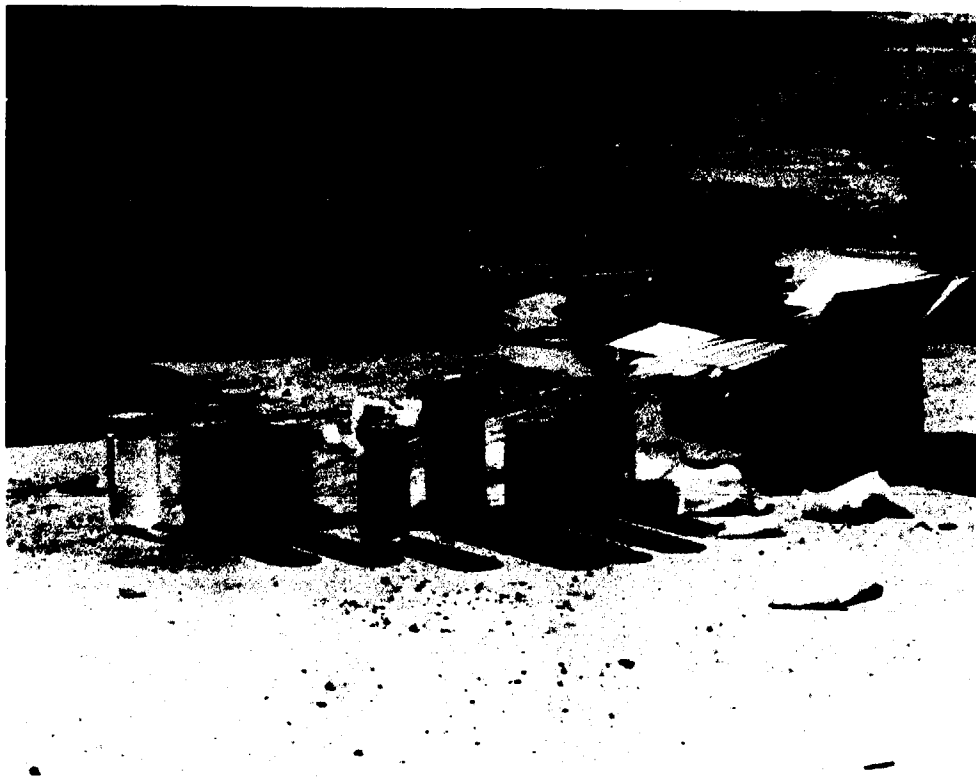
PHOTO #9
OFFICIAL PHOTOGRAPH
ENVIRONMENTAL PROTECTION AGENCY

Subject: A variety of materials were found in the drums and subsequently sampled.

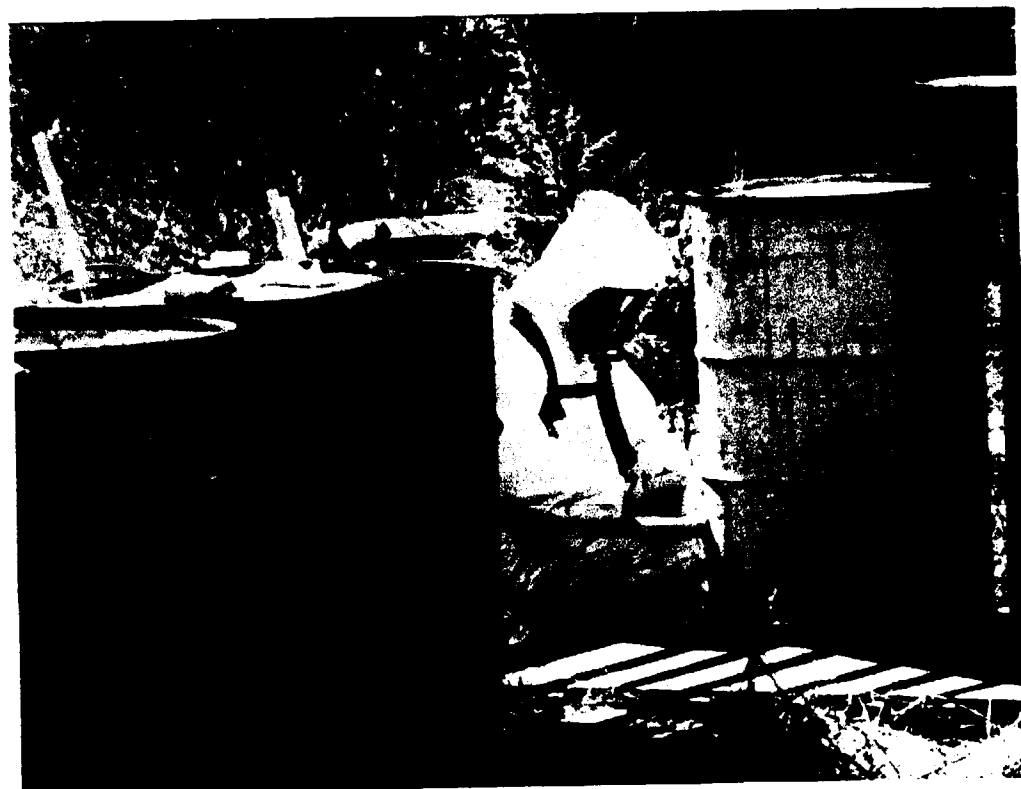
PHOTO #10
OFFICIAL PHOTOGRAPH
ENVIRONMENTAL PROTECTION AGENCY

Subject: Drum markings being noted on the drum log sheets.

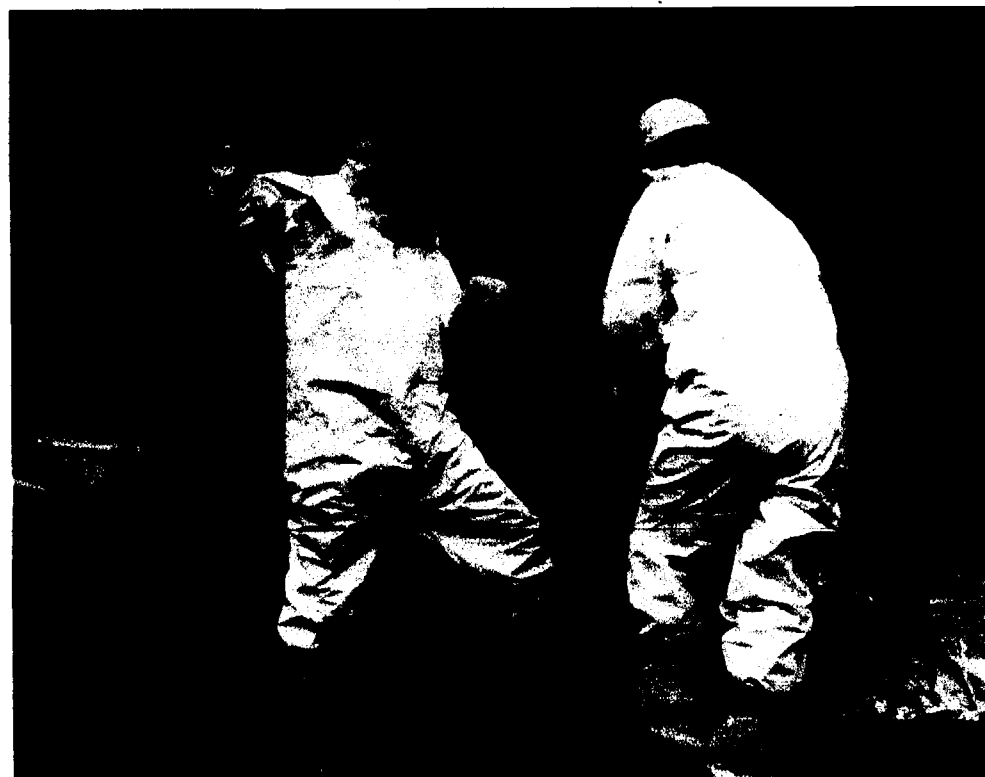
PHOTO #2
OFFICIAL PHOTOGRAPH
ENVIRONMENTAL PROTECTION AGENCY

Subject: ERCS crew sampling drums.
Location: Montreal Court Drum
 Tucker, Dekalb Co., Georgia
Photographer: V. Benfield **Date:** 05/23/90
Film: 35mm **ASA:** 100 **Time:** 1235
TDD# 04-9004-40-3216 **Witness:**
Location of Negatives: Atlanta TAT Office

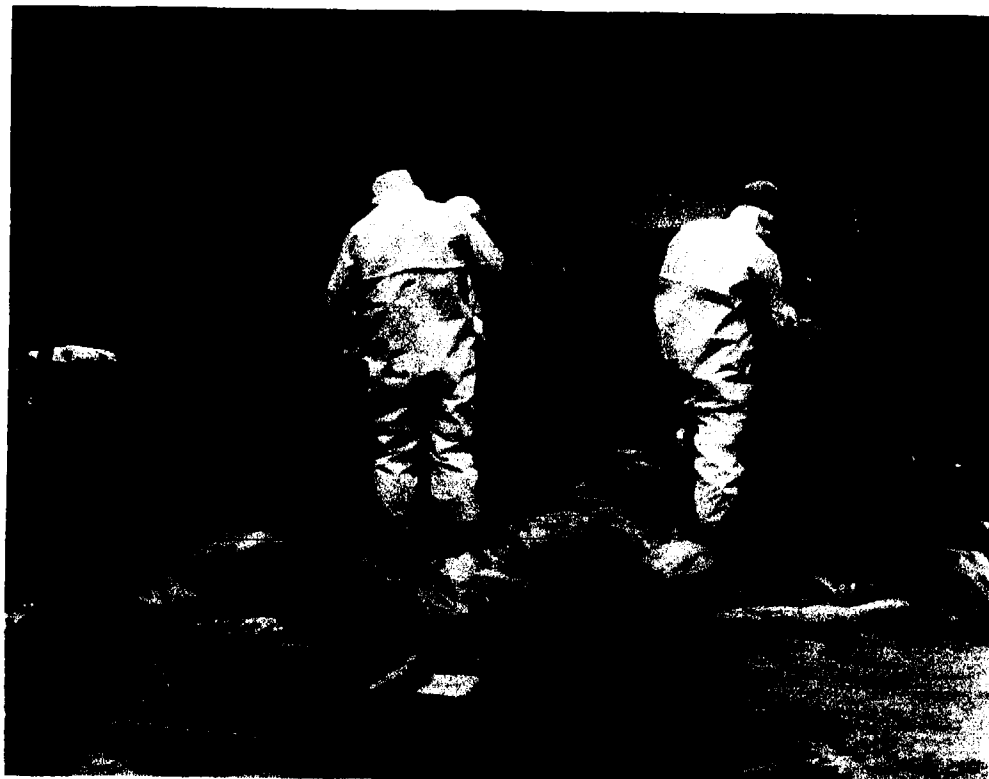
PHOTO #3
OFFICIAL PHOTOGRAPH
ENVIRONMENTAL PROTECTION AGENCY

Subject: ERCS crew sampling drums.

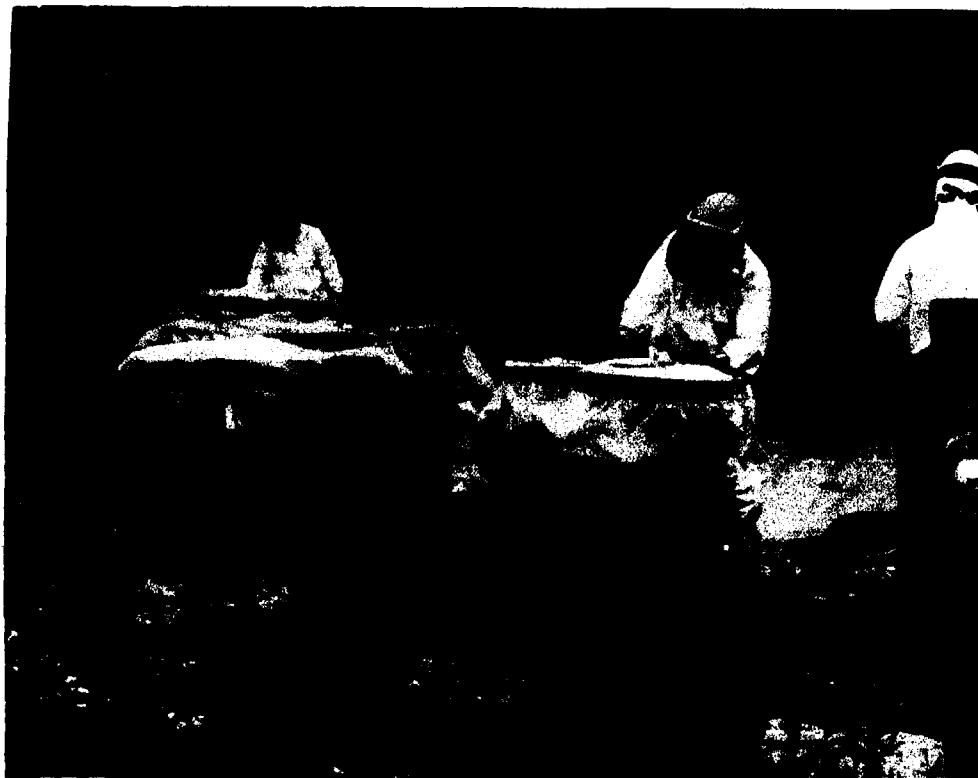
PHOTO #5
OFFICIAL PHOTOGRAPH
ENVIRONMENTAL PROTECTION AGENCY

Subject: ERCS crew covering and securing
the drums with visqueen and tape.
Location: Montreal Court Drum
Tucker, Dekalb Co., Georgia
Photographer: V. Benfield **Date:** 05/23/90
Film: 35mm **ASA:** 100 **Time:** 1345
TDD# 04-9004-40-3216 **Witness:**
Location of Negatives: Atlanta TAT Office

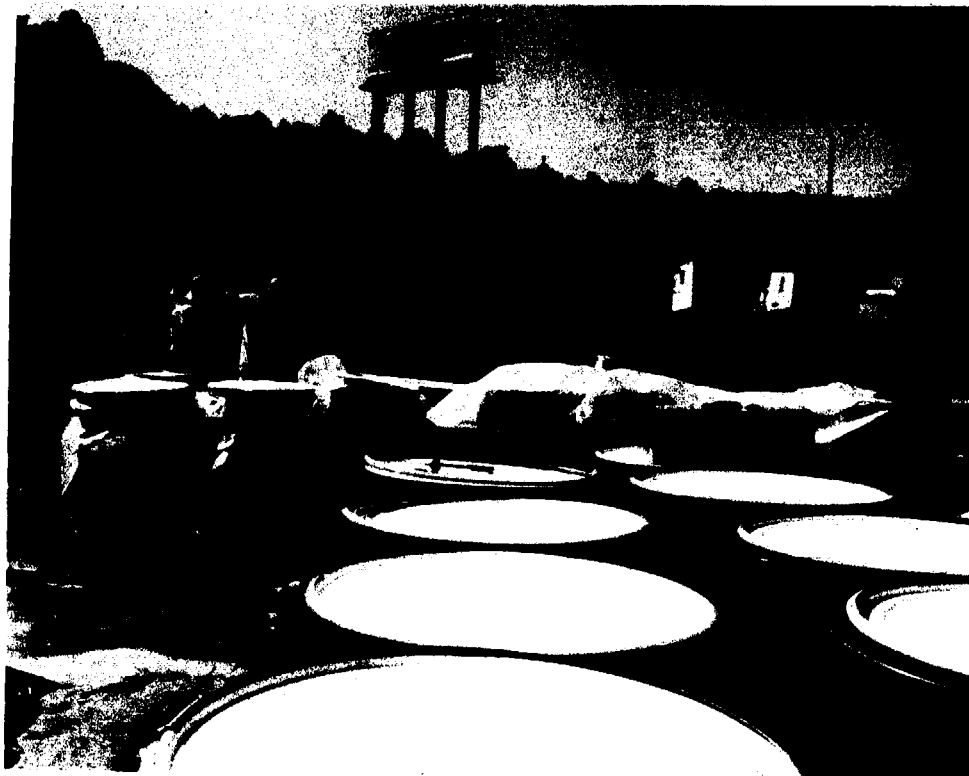
PHOTO #7
OFFICIAL PHOTOGRAPH
ENVIRONMENTAL PROTECTION AGENCY

Subject: ERCS crew establishing drum logs
 for hazardous drum.
Location: Montreal Court Drum
 Tucker, Dekalb County, Georgia
Photographer: V. Benfield **Date:** 05/30/90
Film: 35mm **ASA:** 100 **Time:** 1200
TDD# 04-9004-40-3266 **Witness:**
Location of Negatives: Atlanta TAT Office

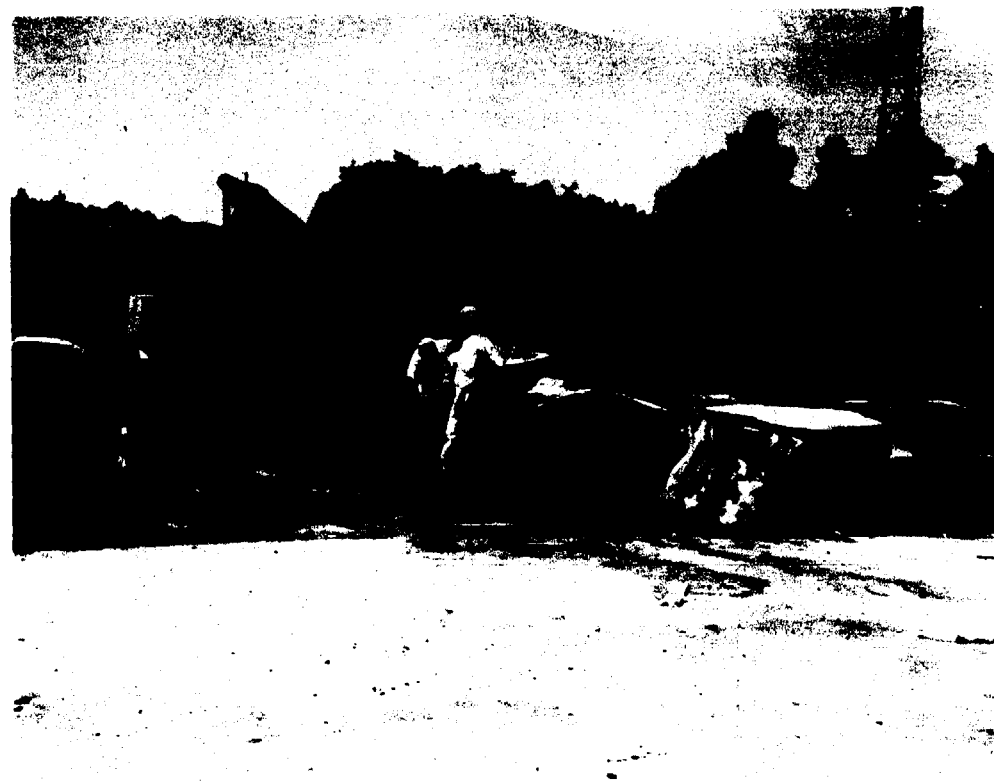
PHOTO #8
OFFICIAL PHOTOGRAPH
ENVIRONMENTAL PROTECTION AGENCY

Subject: ERCS crew overpacking hazardous
 drums.
Location: Montreal Court Drum
 Tucker, Dekalb County, Georgia
Photographer: V. Benfield **Date:** 05/30/90
Film: 35mm **ASA:** 100 **Time:** 1200
TDD# 04-9004-40-3266 **Witness:**
Location of Negatives: Atlanta TAT Office
